Manhole Inspection Summary

Manhole # S51C2_001MH

Insp Date: **5/26/08 11:13 AM**

Location Address: **3601 Fairfield Rd.** Cross Street: **E. Patapsco Ave.**

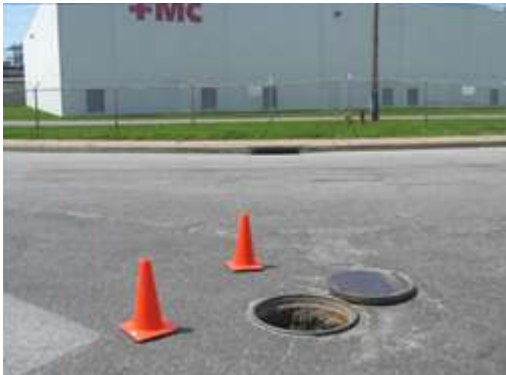
Location View

3601 Fairfield Rd.

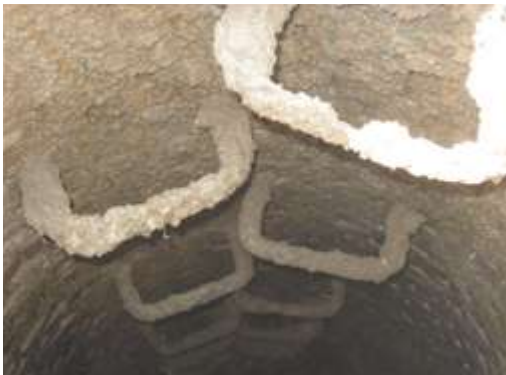
Steps Count: **12** Missing: **1** ☒ **Corroded**

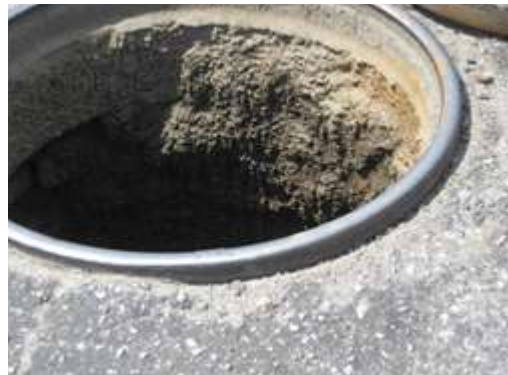
Defect 1

Frame Offset: **2** (in.) Condition: ☒ Sound ☐ Cracked ☐ Leaks

Frame above the grade

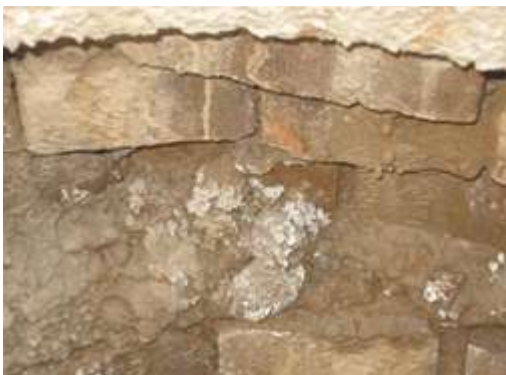
Defect 2

Chimney / Frame Adjustment ☒ Exists Material: **Brick** ☐ Parged Height: **4** (in.)
Condition: ☐ Sound ☐ Cracked ☐ Root Intrusion ☐ Loose Brick ☒ **Deteriorated**
Infiltration: ☐ None ☒ **Joint** ☐ Cracks ☐ Mortar ☐ Roots ☒ **Wall**

Cracked chimney and infiltration

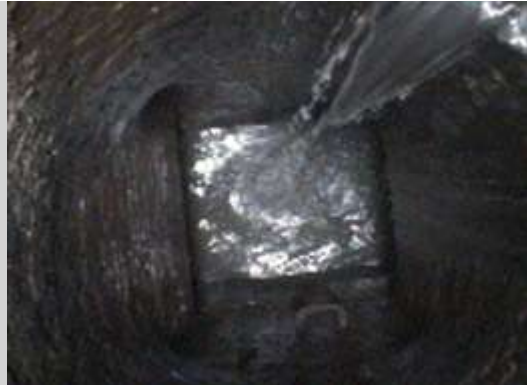
12 O'Clock Outflow

64 in. Circular Gravity Sewer
Pipe Out @ 12 O'Clock

Pipe Height: (in.) Direct (Angled)
Pipe Material: **Unknown** ☐ Pipe Lined
Invert Depth: **3.00** (ft.) Flow Characteristics: **Turbulent**
Deposits: ☒ None ☐ Mud ☐ Gravy ☐ Debris ☐ Grease
Silt Depth: (in.) Deposits Extent:
Infiltration: **None** Pipe Seal Cond: **Unknown**

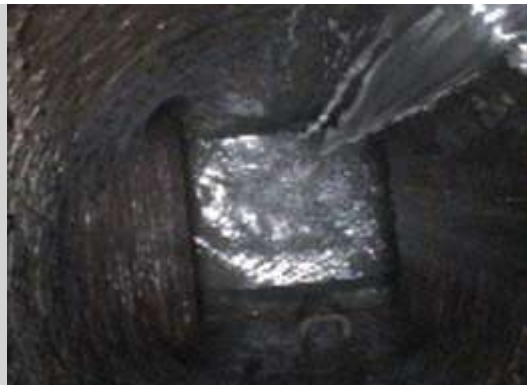
6 O'Clock Inflow

54 in. Circular Gravity Sewer
Pipe In @ 6 O'Clock

Pipe Height: (in.) Direct
Pipe Material: **Unknown** ☐ Pipe Lined
Invert Depth: **3.00** (ft.) Flow Characteristics: **Turbulent**
Deposits: ☒ None ☐ Mud ☐ Gravy ☐ Debris ☐ Grease
Silt Depth: (in.) Deposits Extent:
Infiltration: **None** Pipe Seal Cond: **Unknown**

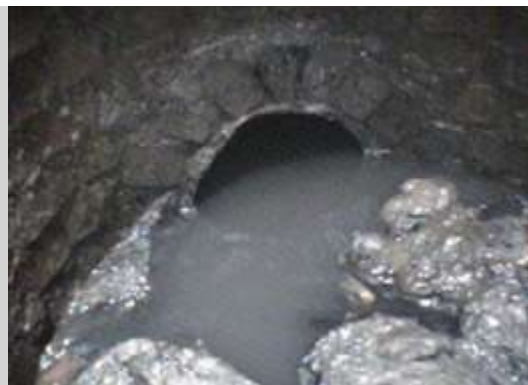
10 O'Clock Inflow

10 in. Circular Gravity Sewer
Pipe In @ 10 O'Clock

Deposits: ☐ None ☐ Mud ☒ **Sludge** ☒ **Debris** ☐ Grease

Silt Depth: **3** (in.) Deposits Extent: **Medium**
